Entering a confined space can be extremely dangerous, even if it's just for a few seconds or minutes, as the tragic stories on the following pages will describe.

New York
Case Report
03NY027

California
FACE Report
11CA009

Michigan
Case Report
16MI071

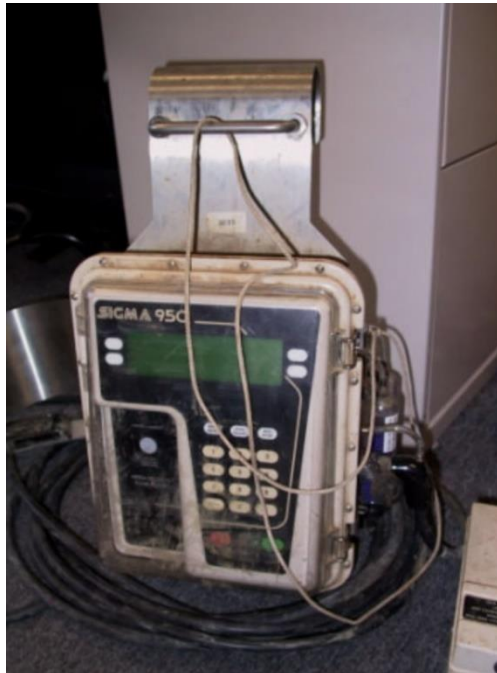
The flow meter that was used to measure the flow rate in the manhole.

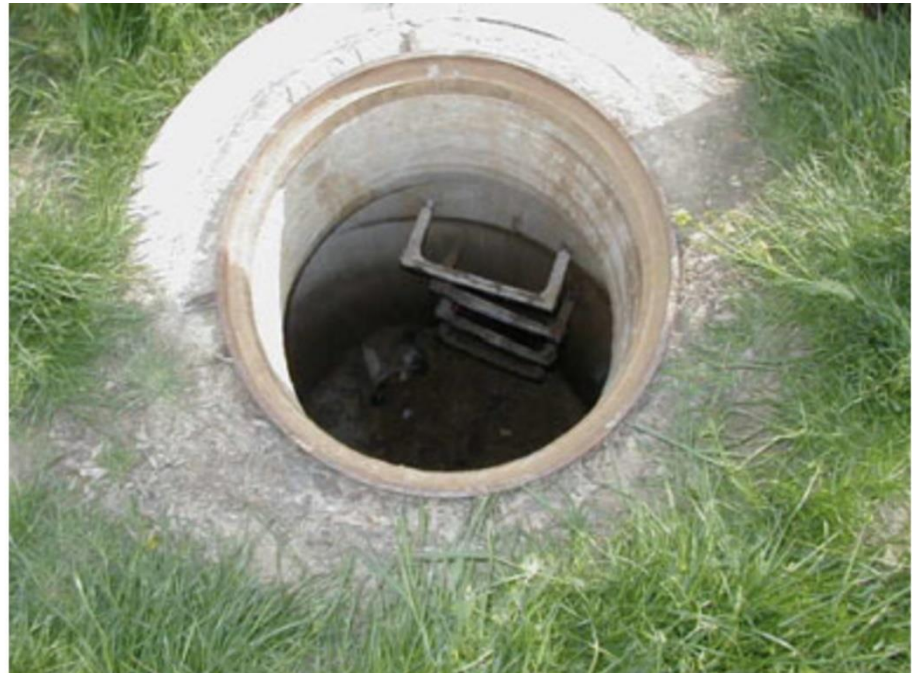
According to the fire department monitoring data, the oxygen concentration at the bottom of the manhole was 2.1% and the flammable vapors exceeded 60% of the lower explosive level (LEL) at the time of the rescue.

The landfill manhole where the fatality occurred.

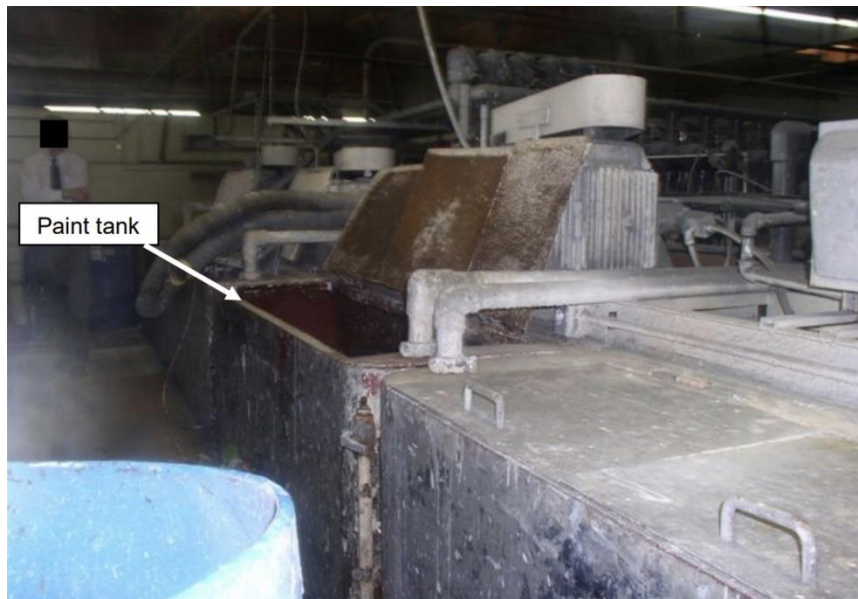
The tank met the requirements for a permit-required confined space, the workspace inside the tank was not adequately ventilated, and the paint maker was not trained in confined space entry. There was no attendant at the tank opening to monitor the work process. The paint maker was wearing a cartridge respirator that did not adequately protect him against inhaling methylene chloride vapors.

The paint tank being cleaned when this tragic incident occurred.

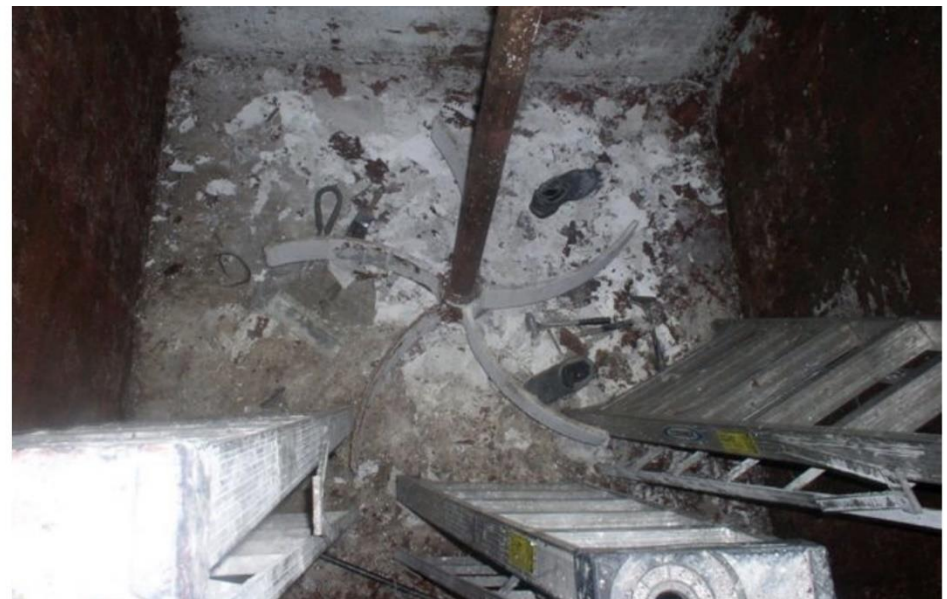
View of the bottom of the tank and the ladders used to enter and exit the tank.

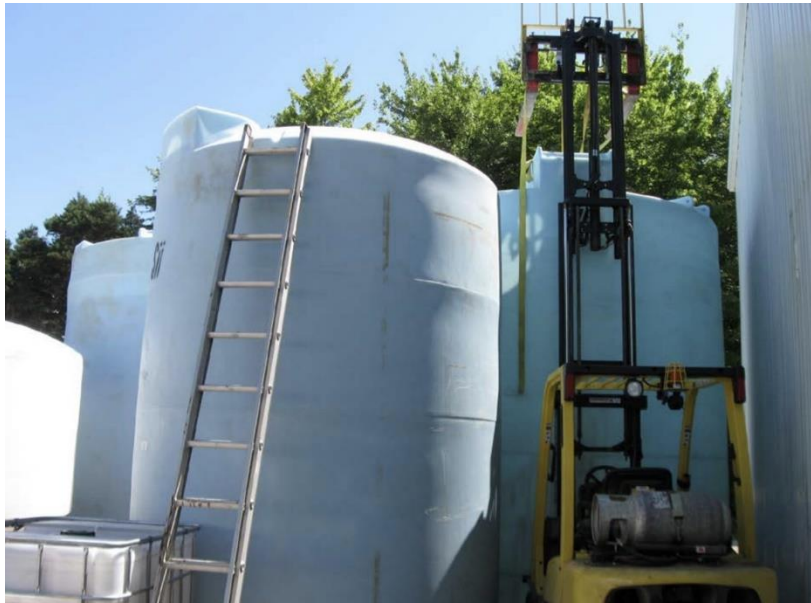
To enter the tank, he placed a lift truck in front of it and raised the forks above the opening. Then he put on a pair of full-length waders and a full-face respirator and rappelled to the base of the tank while holding cargo tie-down straps attached to the lift truck. He was then able to push the drainpipe into position.

Tank where this incident occurred (back right) with the lift truck positioned in front of it.

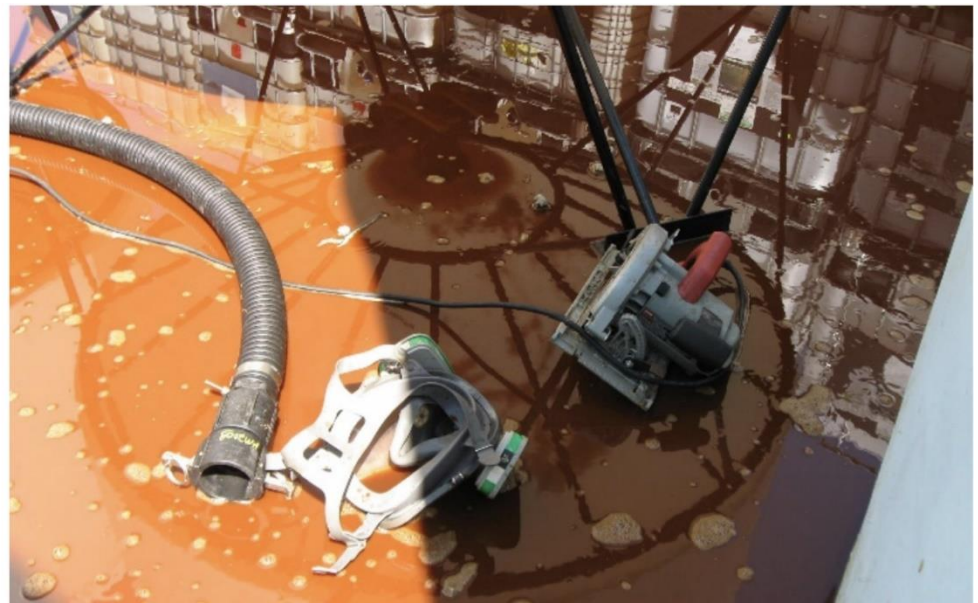
He attempted to climb out of the tank by walking up the side of the tank while pulling on the straps, but then became unresponsive. To rescue him other workers had to cut a hole in the side of the tank with a circular saw where they found he had drowned in the liquid at the bottom. He was taken to the hospital where he was declared dead.

The bottom of the tank where the circular saw and the worker's respirator were left behind.

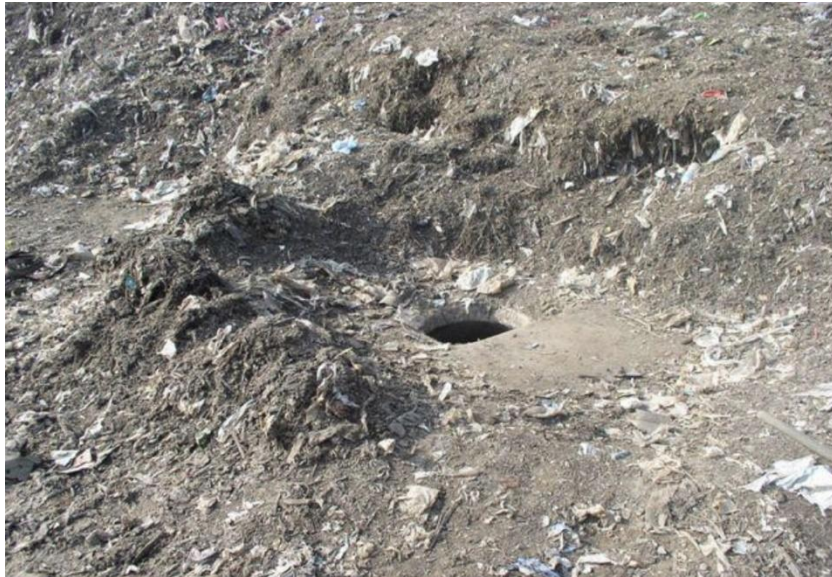
The younger brother (age 16) was standing on the ladder inside the shaft when he was overcome by hydrogen sulfide and fell to the bottom of the 10-foot shaft. The older brother (age 22) attempted to rescue his brother but was also overcome and collapsed at the bottom of the shaft.

The shaft opening.

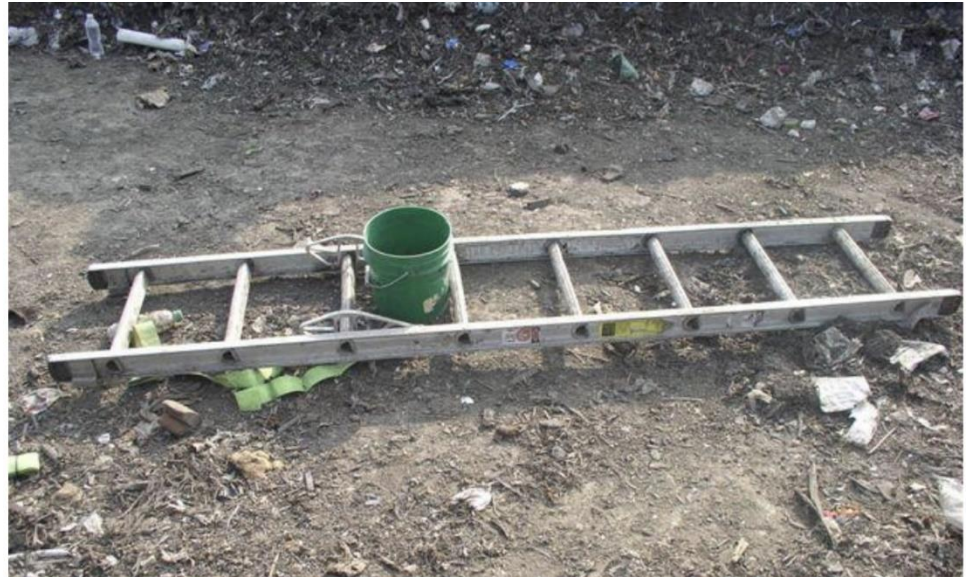
All three workers took turns sitting on the edge of the shaft while using a high-pressure water hose to flush residual compost to the bottom. This cleaning method was unsuccessful, so they placed an 8-foot ladder in the shaft.

The ladder found in the shaft.
